Conservation and Restoration of Painting and Engraving Sites in Western Australia

J. Clarke

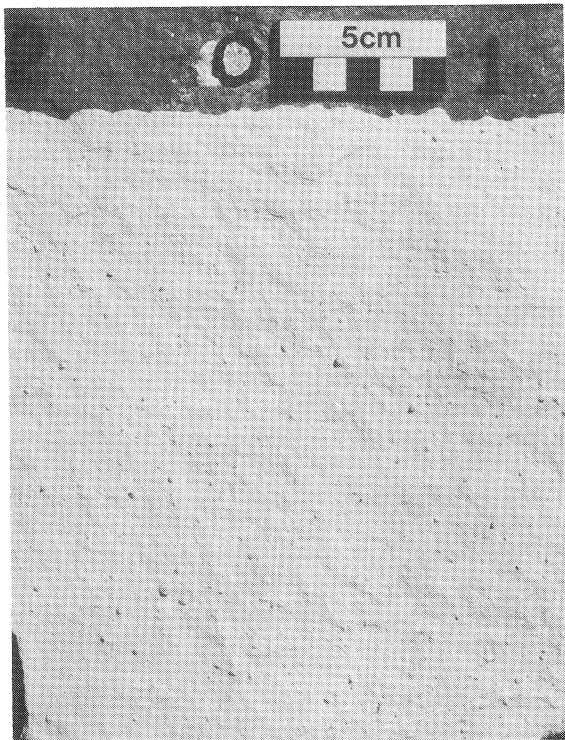
(A) Test sample of a white huntite pigment on quartzite prior to accelerated weathering.
Treatment — (1) combined silicone resin and silicic ester in a highly volatile solvent (2) silicone resin in toluene (0) control — untreated.

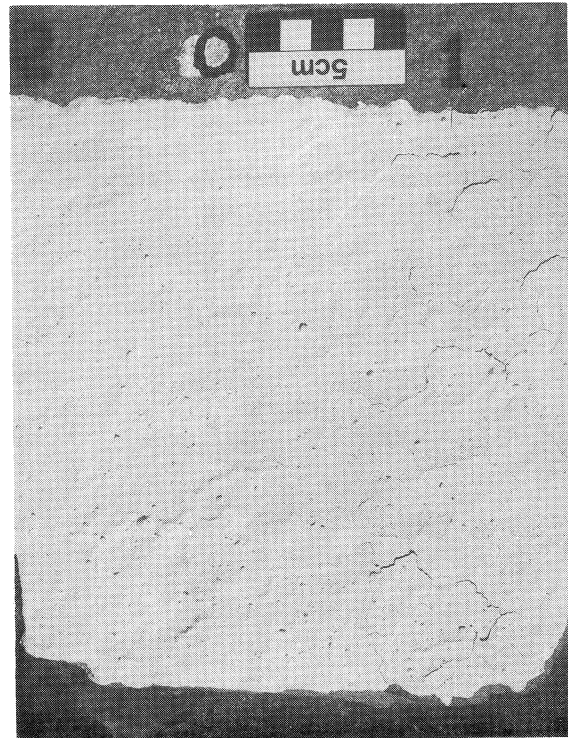
(B) One month accelerated weathering with temperature range 5° to 35°C and R.H. 30 to 90% on a two hour cycle time. Constant ultra violet radiation, at 1.3×10^{-4} watts/cm²/nm between 257 and 392 nm.

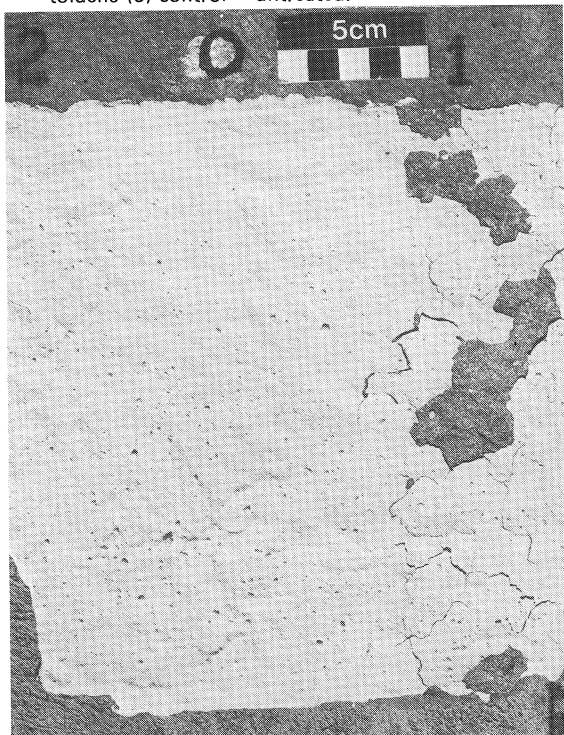
(C) Four months as above. The flaking of treatment (1) was due to a build-up of resin on the surface.

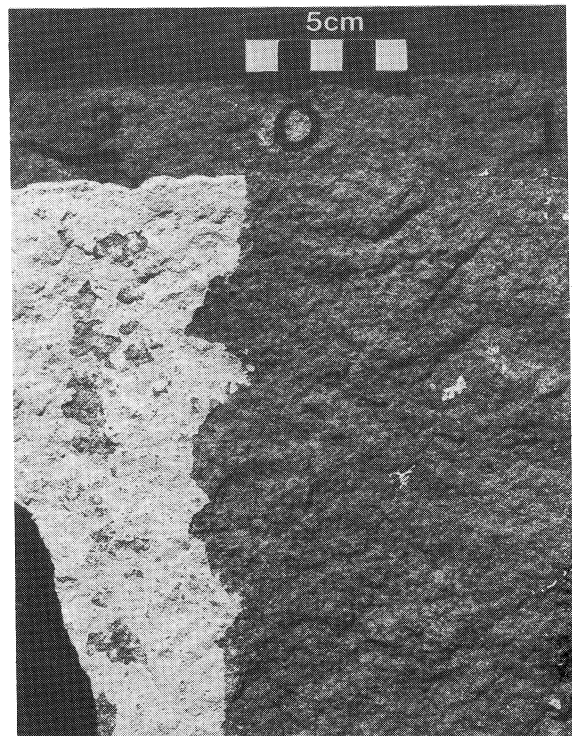
(D) Four months, and water spray for 15 minutes.

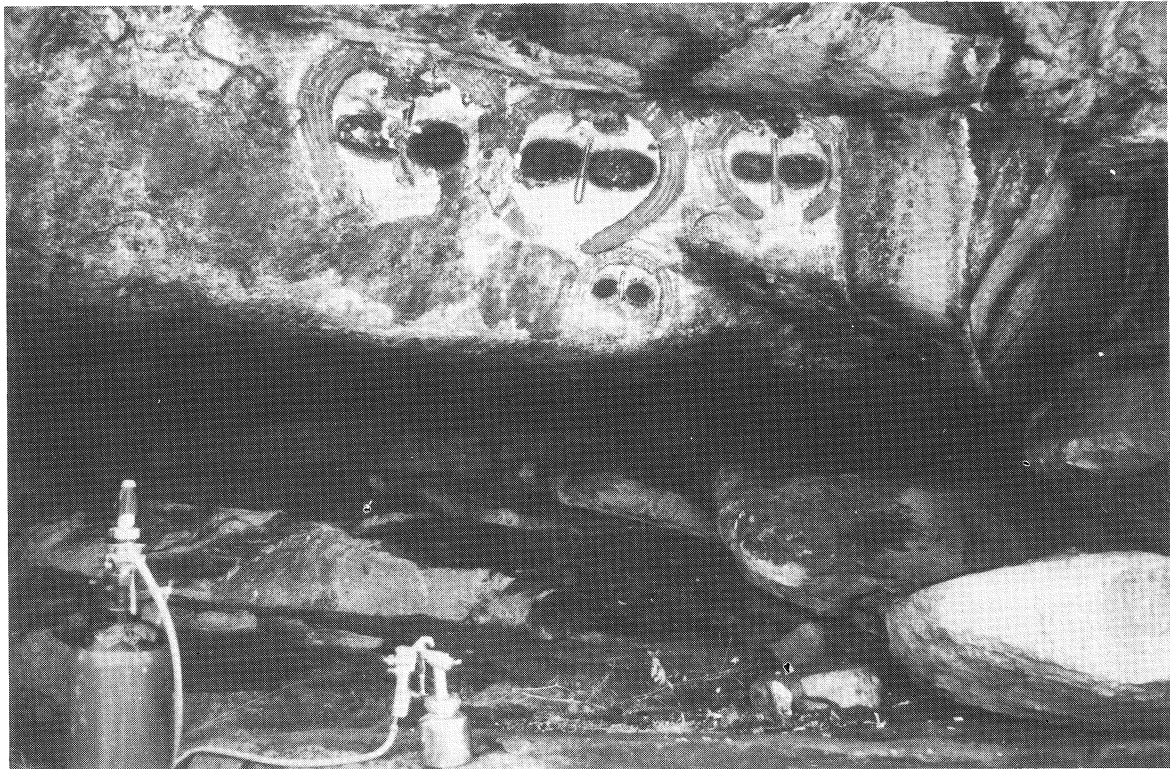
Figure 2. A Wandjina rock art site in northern Kimberley, following treatment with silicone water repellent. Spray equipment in foreground.

The system now used is based on a proprietary brand masonry water repellent called "Goliath" from Raffles Paints Ltd. WA. It consists of a 5% solution of imported silicone resin in toluene or white spirit with 0.05% tributyl tin oxide fungicide. The mixture is sprayed on with a normal spray gun working at very low pressure to limit evaporation. The spray technique is important, the aim being to prevent any build up of resin on the surface as this will cause flaking. A light spray is applied to stabilise the surface then the mixture is flooded on and every precaution taken to limit the evaporation rate such as screening the shelter or wall with polythene sheet. Drying should take many hours.

The result when dry is completely invisible, however water is repelled from the surface and there is an improvement in the mechanical strength of the pigment layers. The key to successful treatment is to get enough resin in to the pigment layers to make them water repellent without making them impermeable by completely impregnating the pore space.
