Part II Endangered site — a famous example

Yiwalalay, N.T. Site No. 00047; map ref: Delamere 5266; map co-ords: 696 653; aerial photographs: Willeroo, Run 29 — 5682, 21.7.72, Aerial Surveys Pty. Ltd., Perth.

Yiwalalay, the site made famous by the two large figures of Yabiringi and Yakjagbula, the Lightning Brothers, is situated approximately fourteen kilometres west-south-west of the new Delamere Station. It is a twelve metre high residual rock of very soft sandstone with a prominent overhang located on

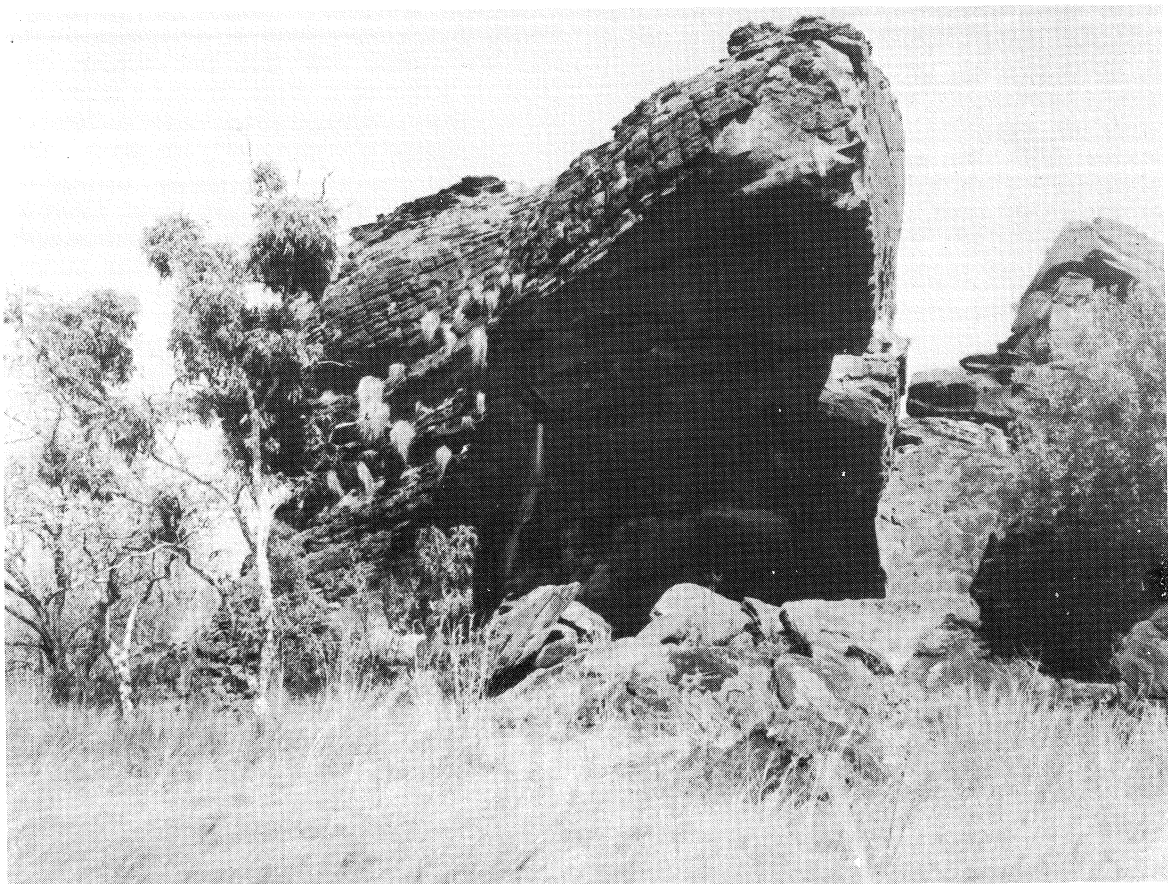
Figure 2: Yiwalalay rock, with the Yanginjanawuya shelter in the shadow of its overhang. One source of water-wash is clearly visible, while a bud of efflorescent mineral salts, deposited there by the activities of the second water-wash channel is noticeable above the roof fall protecting the western aspect of this shelter.

Yiwalalay rock has three separate rock painting areas. The major one is the Yanginjanawuya shelter with the paintings of the Lightning Brothers and other designs on its back, curved wall exposed to the late afternoon sun. The shelter is well protected by its high, deep overhand (Fig. 2). Its occupational area is further protected by a large fall of rock from the ceiling of the overhang which except for a narrow entrance completely encloses the site. The collapsed rocks protect the lower interior from driven rain and from direct afternoon sunlight, making it an ideal wet season living space. At the same time the inward surface of the largest fallen rock provides an additional area for painting and engravings. Its smooth perfectly vertical surface is covered with simple engravings and is completely painted over with a large number of anthropomorphs and animal designs in a number of styles. There are several bird species depicted including that of a spoonbill. There is also a contact painting of a man with two rifles shooting cattle. This is depicted in simple silhouette using white pigment only. External surfaces of the protective rocks are covered with engravings of random oriented parallel lines, bird tracks and shallow ground hollows. In between, one can find initials engraved in the soft rock by visiting Europeans.

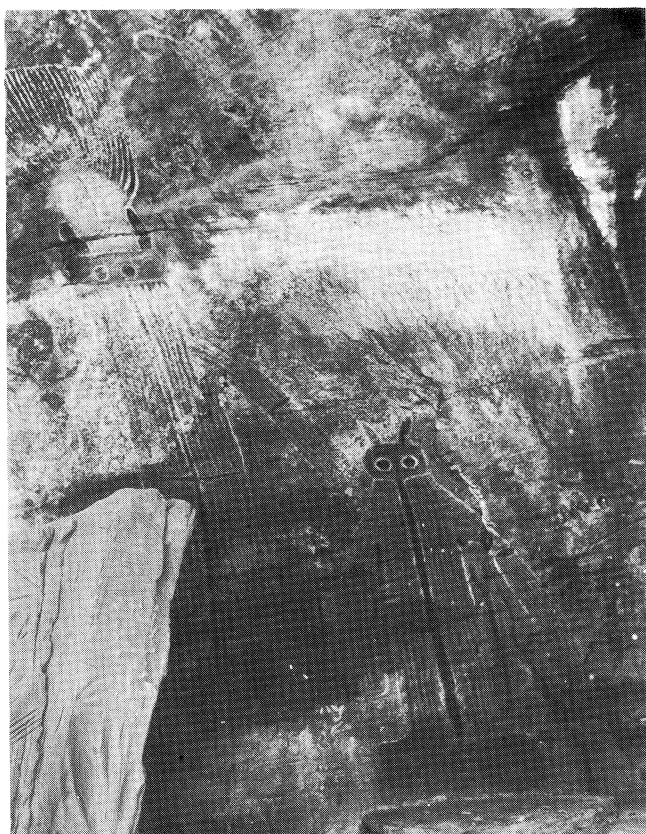
Figure 3: Photograph of the two Lightning Brothers, Yabiringi and Yagjagbula as found in October 1977. The activity of leached mineral salts has almost completely disintegrated the rock surface over the upper half of the larger figure, while dendritic channels are reaching the vicinity of the smaller figure. The larger figure is 417 cm and the smaller 284 cm high.

On the back, inward convex wall (its shape indeed suggesting that this could be a fossil sand dune) amongst many other paintings are the two impressive figures of the Lightning Brothers (Fig. 3). Yabiringi, the larger figure is 417 cm high, while Yagjagbula, the smaller figure measures 284 cm. They have been executed in a combined painting and engraving technique, using the four common pigments of red, yellow, white and black. Both figures are outlined and have internal divisions and detail such as eye outlines and head-dress decorations in white pigment. The schematized faces are red, with the interior of the figures infilled by alternate, parallel yellow and red stripes. Although it is the same red pigment used on the heads of the two brothers, the juxtaposition of red and yellow gives the red an illusory effect of added brightness. Black pigment was used in the eyes, ears, armpits, penis, joint marks and internal division and the stone axe handle. The penis of both males terminates in long red ochred grooves deeply incised into the rock (Fig. 4). Although much of the white pigment outlining the external parts of the designs has weathered away, the figures, except for the damage to the larger figure, remain as they were described by Arndt and photographed by Donkin. The designs were not altered or added to in the past 21 years.

However the continuing deterioration of the larger figure is such that if not arrested it could completely obliterate that design. Similar agents of deterioration are acting on the painted surface immediately above the smaller figure.

The damage is caused by two areas of water wash and seepage of internal water, rich in soluble salts. The main water wash entry is to the right and above the figure clearly visible on the photograph. As it moves down the rock face it enters a fault line and moves across to just above the main figure where the leached solution runs down the painted design. During the dry season the mineral rich solution evaporates and leaves the white crystalline salts in the pores as well as on the surface of the rock. As this mineral salt happens to be very soluble and hygroscopic, it takes up moisture from the atmosphere during the next humid period, expands, loosening surface particles of this soft porous rock and these are then washed or fall away. This gradual disintegration of the rock surface and its actual breakdown occurs here in two different patterns. In one instance the soluble salts percolate through the rock mass above the main figure and leave the upper half of the body and a large area to its right thickly covered in white crystalline salts. The subsequent cycle of expansion and re-crystallization of this salts causes rapid breakdown and weathering of the rock surface which in this case takes form of random action leaving "islands" of the original

surface. These patches are further undercut, salts crystallize underneath the "island" shelves and these too will eventually weather away. The soluble salts active on the surface to the right of the larger figure and immediately above the smaller one are in the path of a water wash which re-dissolves it and carries it away with the loose rock particles down the wall in a dendritic pattern, leaving eroded channels in the rock surface. The salts are deposited lower down the wall and in time will move over Yagjagbula, the smaller of the two Lightning Brothers.

This general report, bringing to notice the state of the shelter as it is at the present, with a simple description of physical and chemical causes of weathering, should be followed by a detailed multidisciplinary scientific investigation culminating in first conservatory measures. As the damage is basically water induced, the first step in practical preservation of this site would be to prevent rainfall from entering the rock mass. The top and sides of this residual should be inspected for any opening, and these, pressure sealed with clear silicone or suitable hydro-epoxies. The existing sources of water-wash (Fig. 3) must be isolated and the water diverted away from the painted areas. At the same time the rock art of the three shelters should be recorded in detail. Although a number of investigators visited the site and published photographs and descriptions of the two main figures, it seems that other paintings have been overlooked. Arndt² mentions several designs from the eastern shelter, some of which he says "bear resemblance to those described by Davidson¹ and reproduced by McCarthy⁶".

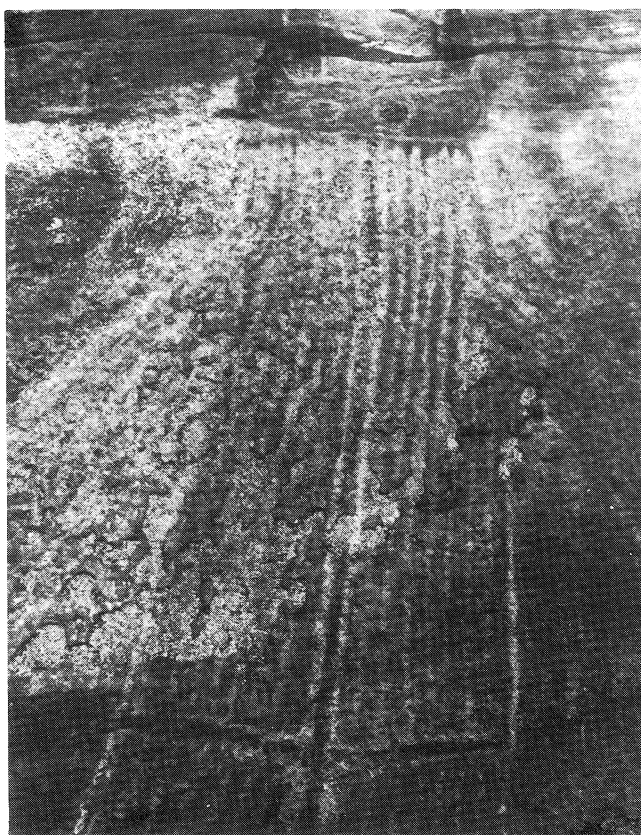
Figure 4: Detail of the lower part of Yabiringi's body, where it was superimposed over earlier engravings of macropods tracks. His penis terminates in a long, red ochred groove deeply incised into the rock.

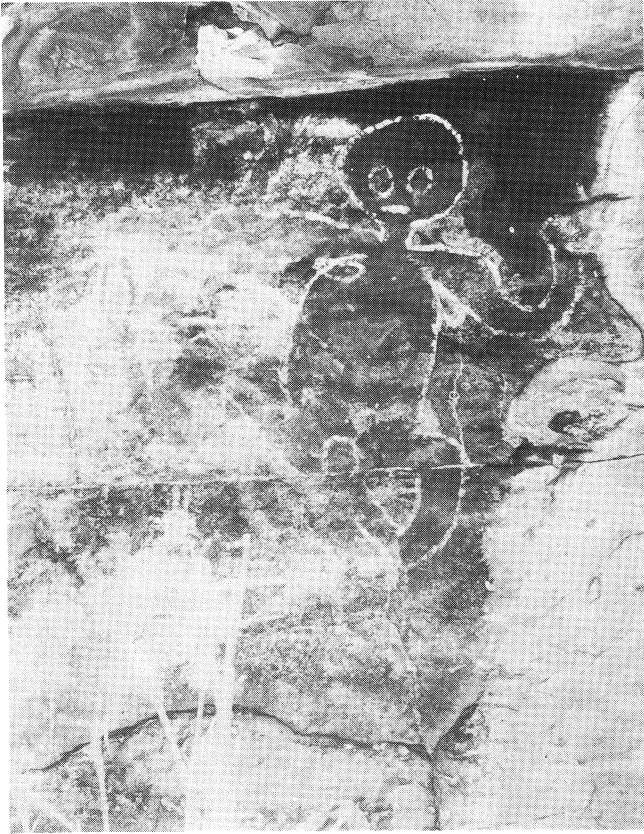
The two brothers are associated here with paintings of their wives who are depicted in much smaller proportions and in less elaborate design. Ganayanda, Yabiringi's wife (Fig. 5), is situated just outside the entrance of the shelter, some eight metres from his representation. She appears as only a 73 cm high frontal silhouette in red with a white outline. This painting is only slightly protected from elements but not subject to water wash. Its left half is weathered but the right side and upper part of the body protected by a shallow overhang is well defined. Gulidang, Yagjagbula's mate is situated just to the right of his figure. She remains there, barely visible as a red stain with traces of white pigment outlining her body and the deeply incised, black pigmented vulva. She is only 33 cm high (Fig. 6).

Figure 5: Yabiringi's wife Ganayanda on an exposed wall outside of the actual shelter. This simple figure in red and white is 73 cm high.

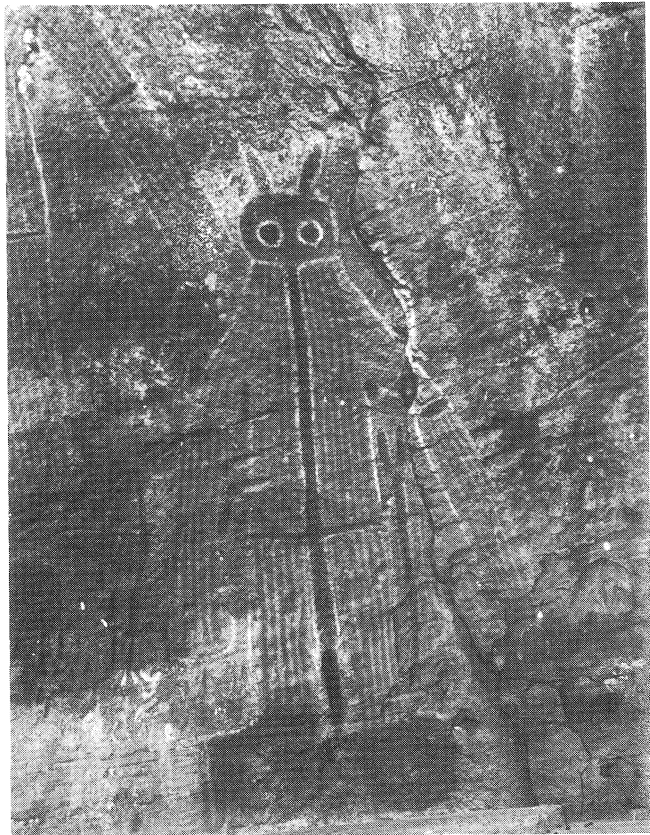
Figure 6: Yagiagbula, the smaller figure except for the loss of much of the white pigment outlining the body, is well defined. However the dendritic pattern in the disintegrating rock surface above warns of future damage. Gulidang, his wife, whose small representation is barely visible to the right of his body, remains as a red stain with traces of white pigment and with deeply incised vulva.

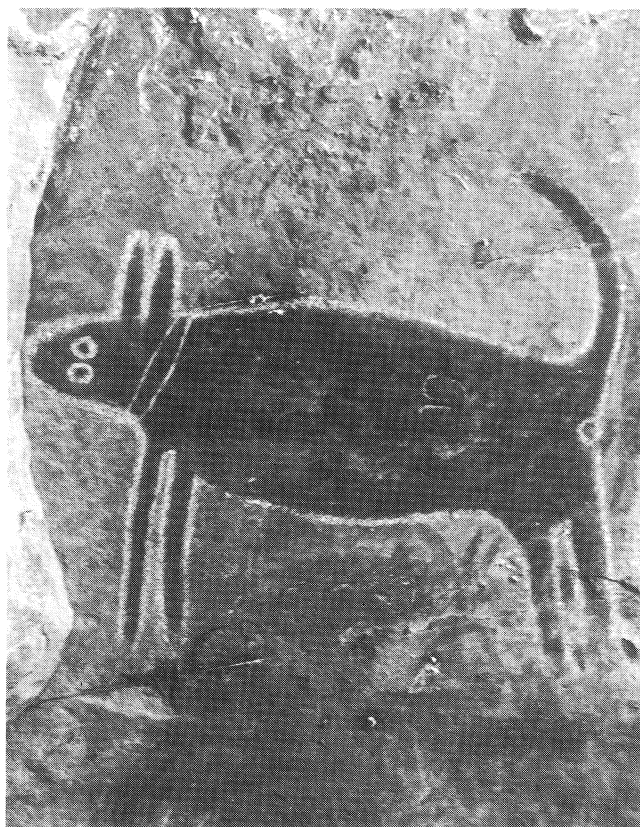
The southern shelter is hidden behind trees and shrubs and consists of a slightly protected vertical wall on which three paintings predominate. These are a spiny ant-eater and a long necked turtle, both in a plan view and executed as red silhouettes outlined in white, and a large quadruped in side view. The quadruped too has been painted in red and white and has, as well, a double joint mark at the neck and white outlined eyes and anal opening (Fig. 7). It is depicted with two yellow kidneys outlined in white. There are also a number of smaller macropod designs in yellow and traces of human figures can be recognised.

Figure 7: Painting of a quadruped from the southern site.
