A TALE OF TWO CRANES

The Sydney Harbour Bridge is an internationally recognised Australian landmark. The distinctive 'coat hangers' of the bridge also served as rails for four cranes to traverse the structure. These cranes were used for construction of the arches between 1928 and 1932, and then for maintenance of the bridge until they were decommissioned in 1997. Heritage approval for their removal from the bridge was conditional on the conservation of two representative examples, with at least one to be put on permanent public display. The remaining two cranes were scrapped.

This paper is an account of both treatment approaches and the rationale underlying them.

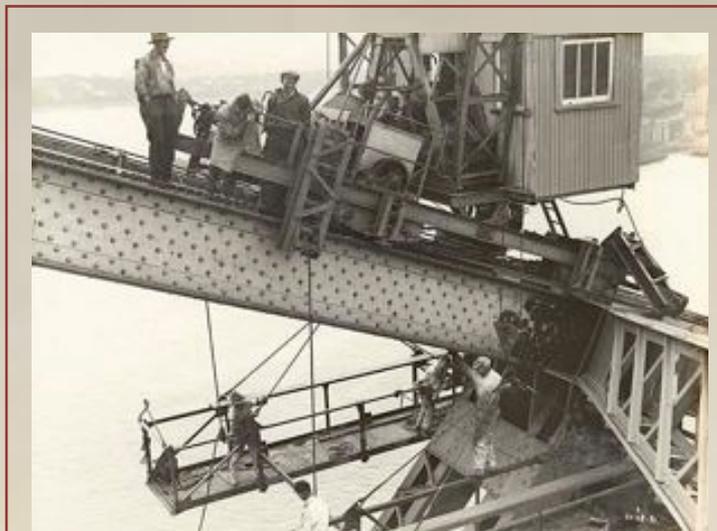
Four ‘travelling maintenance cranes’ were installed on the bridge in mid-1930. The cranes moved up and down the arches of the bridge, enabling workers suspended on maintenance stages, or gantries, to construct and then paint and maintain the structure. The cranes were in service until 1997 when they were removed from the bridge and replaced by modern cranes that met higher OH&S standards. The cranes were a familiar part of the Sydney skyline for 67 years, as Sydneysiders tracked their progress over the bridge that was, according to legend, painted continuously (Figure 1 – from State Records NSW http://investigator.records.nsw.gov.au/asp/photosearch/photo.asp?12685_a007_a007_04_8733000077r).

Figure 1 | Painting Crane on East Top Chord [during construction of the Bridge, 11 Dec 1931].

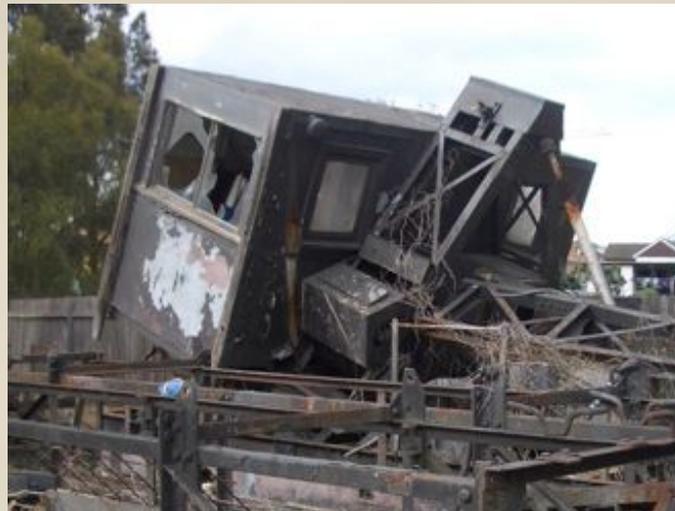
When the cranes were removed from the bridge, the crane arms were cut off and the chains, cabling and other associated gear placed on top of the platforms. They were then taken to the RTA’s Rockdale depot where they remained for 11 years. After sitting out in the weather for this time they showed signs of rust, paint flaking and water-affected wood.

Figure 2 | Condition of crane before treatment.

- Preliminary removal of plant material and debris (accumulated over 11 years of outdoor exposure) undertaken by sub-contracted lead and hazardous materials removal specialists.
- Wrapping with 25µm plastic stretch film to ensure all hazardous substances were contained for transport.
- Lifting, loading and transport to offsite specialist facilities
- Controlled removal by light water blast of any further unstable lead paint; some red lead paint remained, but was considered stable enough to retain as is.
- Treatment of exposed iron corrosion with tannic acid.
- Light wash of interior cabin and timber surfaces using sugar-soap solution.

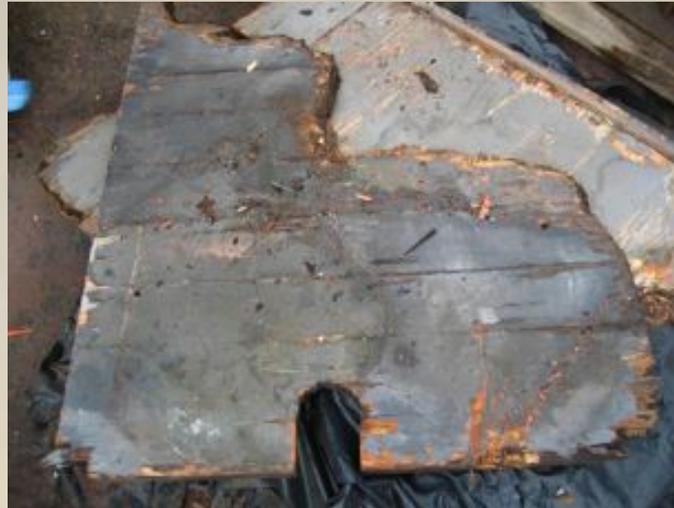
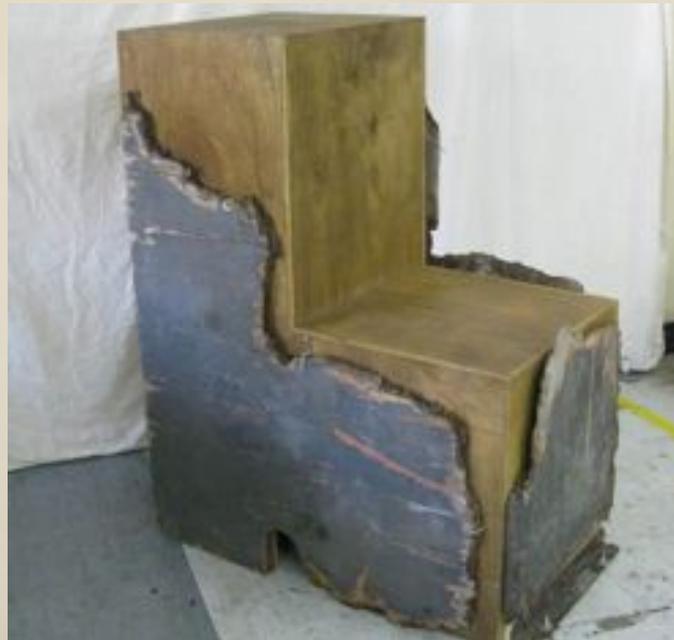
Figure 3 | NMA Motor controller box pieces before and after treatment (mounted on new timber frame).

the cabin for transport, but retained, wrapped and stored in the cabin. Also retained were original timbers from the traverse motor controller on the front of the crane. The partially rotten and incomplete timbers were mounted on a new frame, using non-penetrating temporary fixings. This solution served to both conserve and aid interpretation of the items.

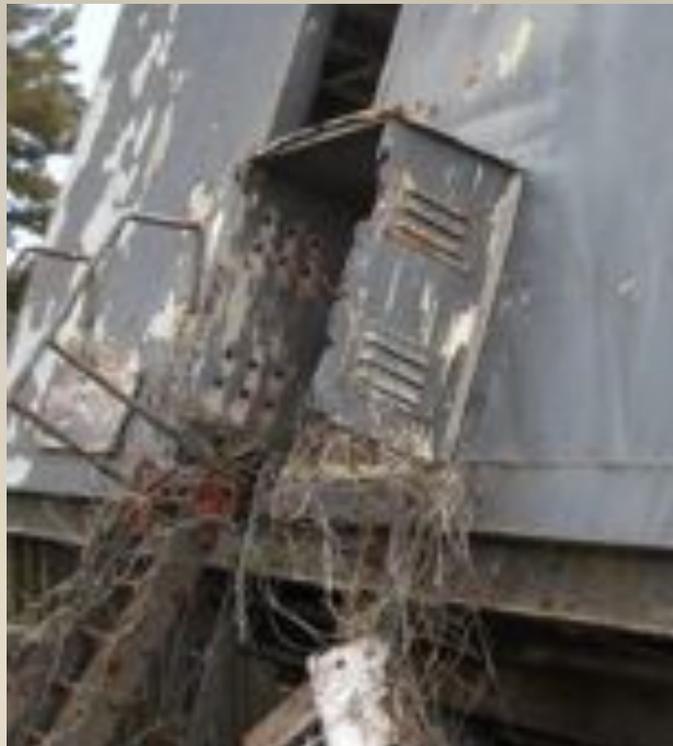
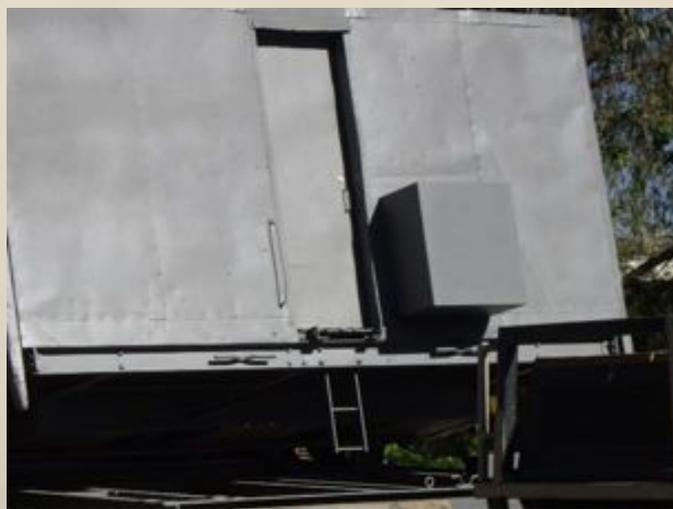
Figure 4 | RTA equipment housing before and after treatment.

The equipment housing on the back of the crane required replacement as the original could not be repaired to withstand outdoor exposure. The new housing was fabricated from steel sheeting (rather than timber plywood as per the original) for long-term durability. The dimensions were taken from equipment housing located on another crane, therefore enabling a representative housing to be fabricated.

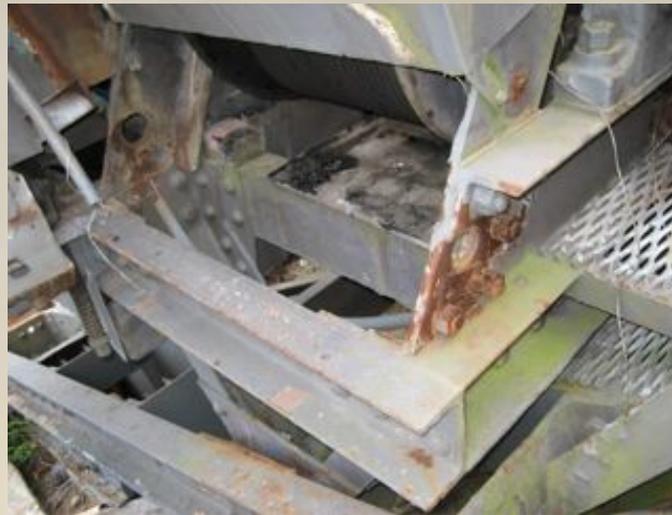
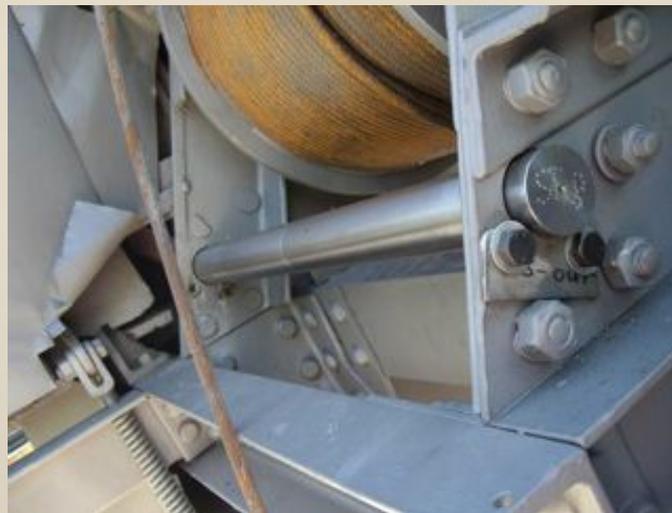
Figure 5 | Cable drums with missing jib pins before treatment (top) and with new stainless steel jib pins installed after treatment (bottom – note jibs not yet installed pending relocation for display).

- Retention of all loose or damaged original elements including original operator hand tools.
- Design, fabrication and trial installation of new jib pins. New jib pins were provided to the same design and specifications as the restored crane (see RTA approach below), the originals having been cut with oxyacetylene and rendered irreparable.
- Design and fabrication of support trolley and crane cover for storage.
- Production of measured drawings for archival purposes.

New jib pins (used to erect the jib in place at the chassis) were required as the originals were cut during decommission and removal from the Bridge. During the treatment process, it became apparent that due to the configuration of engine and rotary parts on the chassis, the jib pin could not be reinserted as a single-piece unit without in turn dismantling much of the cabin and chassis. A new design involving a three-piece jib pin was developed and certified by structural engineers to ensure that it would be structurally adequate for anticipated jib loadings. Drawings and certifications were obtained for new jib backstrap fishplates, also required for future re-assembly.

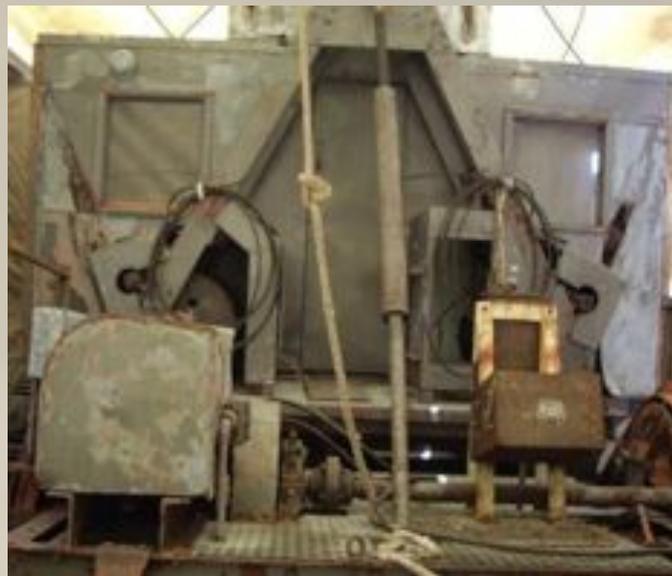
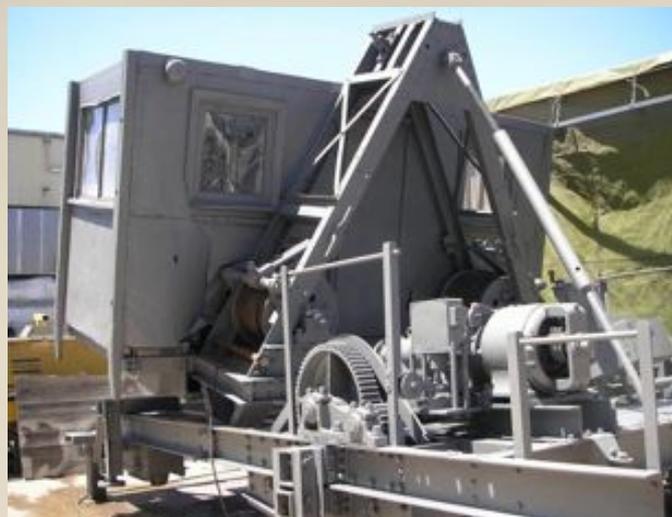
Figure 7 | Cranes after ‘preservation’ (top) and ‘restoration’ (bottom) treatment.

The NMA treatment was based on a minimal intervention approach, yet within the guidelines of AS4361.1, where as much of the original fabric of the crane as possible was retained, including stable paint deemed not to be a hazard. It had been established the crane was to be stored indoors in a relatively stable environment (Canberra has average low humidity) therefore further degradation of paint and metal would be slow. The crane would be managed

- Lifting and transport to offsite specialist facilities for repainting of all elements.
- Controlled removal of both original paints and hazardous materials, including lead-based paint by abrasive blasting (removed to AS Class 2½ grey metal, paint contained with custom-made enclosure in canvas tarpaulin); and paint stripper (PeelAway 1, collected and disposed of in EPA certified facility).

- The crane was then repainted (all exterior elements) with a protective coating rated to outdoor exposure. An epoxy zinc primer (75µm thickness), intermediary coating (epoxy intermediate, 125µm thickness) and two-pack epoxy/polyurethane micaceous iron oxide (MIO) topcoat (150µm thickness) was applied. A MIO in "Bridge Grey" was selected to replicate the original colour.
