Conservation treatment of textiles in the Springfield Landau at the National Museum of Australia

Carmela Mollica & Kerryn Wagg

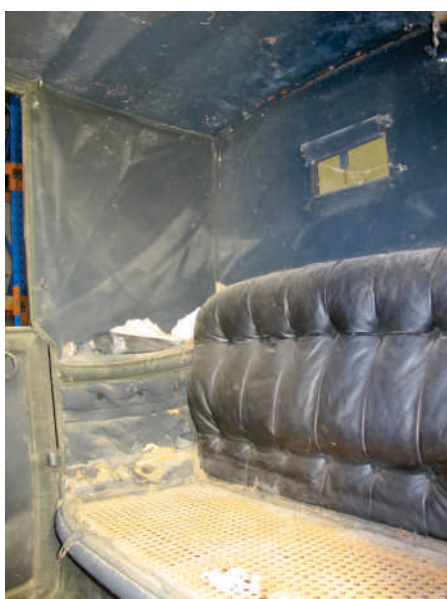
*Landau interior before treatment
- proper right upper rear corner*

Although the landau was once a very luxurious carriage with a convertible roof, it was no longer able to be opened due to the condition of the external leather lining. Before treatment, the interior cabin was in poor condition with significant grazing and nesting by insects and rodents throughout. There were many accretions and drifts of storage dirt and debris including lining materials, rodent faeces, insect frass, insect casings and card and plant materials stuck to the wool.

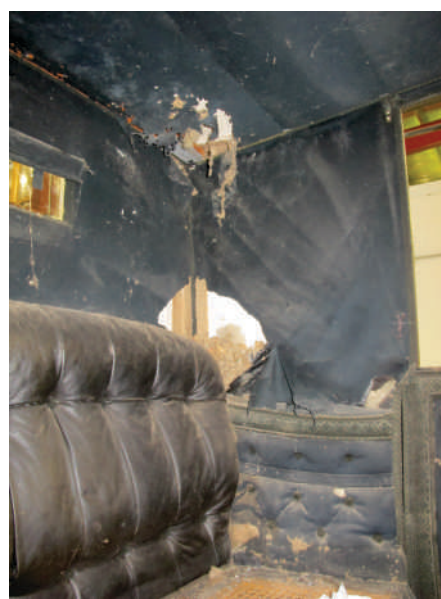
*Landau interior before treatment
- proper left upper rear corner*

The wool upholstery (which was still fairly well tensioned) and lining materials (hessian, horsehair, coir, coated cotton leatherette) exhibited many tears, holes and losses. There were significant losses on the fore seat and back seat arm supports and to all the side wall panels at the elbow line. The back end ceiling panel was significantly damaged, particularly the back proper left corner. Remnants of tassels, upholstery materials and card were used as nesting materials behind the wool in the recesses of coir and horsehair.

The final area of the interior that required stabilisation was the very badly damaged back proper left corner. As this area would not be visible during the exhibition, and timeframes did not allow for full treatment, temporary reversible measures were utilised. To clearly show that these areas were intended as medium term stabilisation, untuned black 100% wool 390 gsm fabric was chosen.

A square of fabric was used to encapsulate the damaged areas of ceiling fabric and this was secured in place with cotton thread stitches through existing holes (where possible) and furniture tacks into the wooden framework. Large panels of black fabric were inserted into the areas of loss in the wall panels and these were again stitched into place with cotton thread.

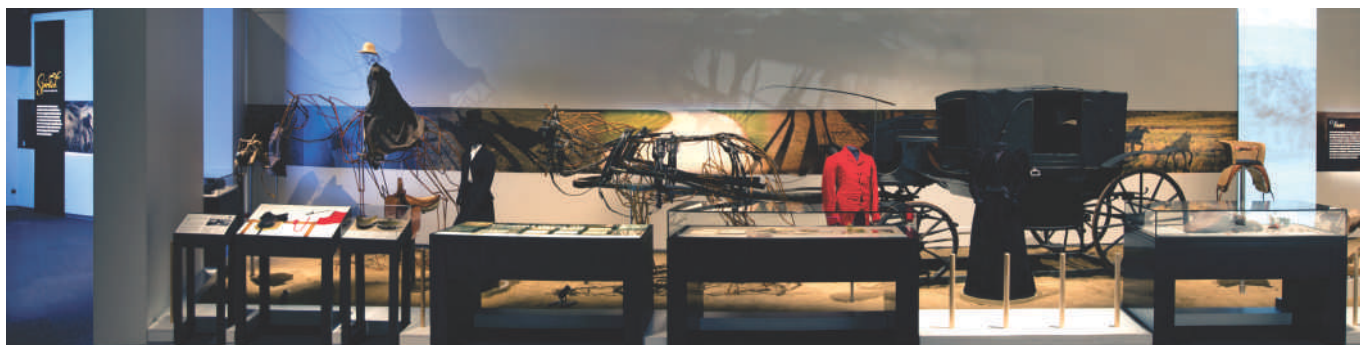
The restored Landau in its final display

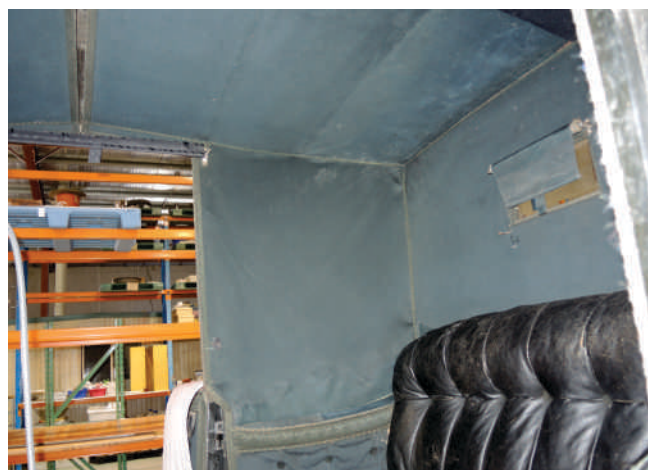
Landau interior after treatment - proper upper rear corner (area most visible during exhibition)

An order of application for the wool repairs was devised with consideration of how each repair would affect access points for further repairs. The areas that would be visible during display were also considered when devising a methodology for the work. As the back proper right upper corner would be the most visible during exhibition, work started in this area followed by the ceiling, proper right front corner, seat side panels, proper right back then front armrests and temporary stabilisation repairs to the back proper left corner.

The fabric of the back wall was entirely detached from the ceiling and proper right wall at the proper right rear upper corner. As there were many holes in the area of back wall fabric adjacent to the rear proper right corner a large piece of new, toned, repair fabric, which could sit behind the majority of the holes, was prepared by using thread anchors stitched and tied along one edge.

Beva® film was applied along one long and one short edge of the repair fabric. This was rolled and inserted behind the detached section of back wall fabric. Once in place it was unravelled flat and a heated spatula was used to activate the adhesive through a layer of silicon release in front of the original fabric.
